Information Sheet IS24005

GV Series: Using the System Health Eligibility Evaluation Program (SHEEP)

Issue 1.205 February 2025

Nautel Limited

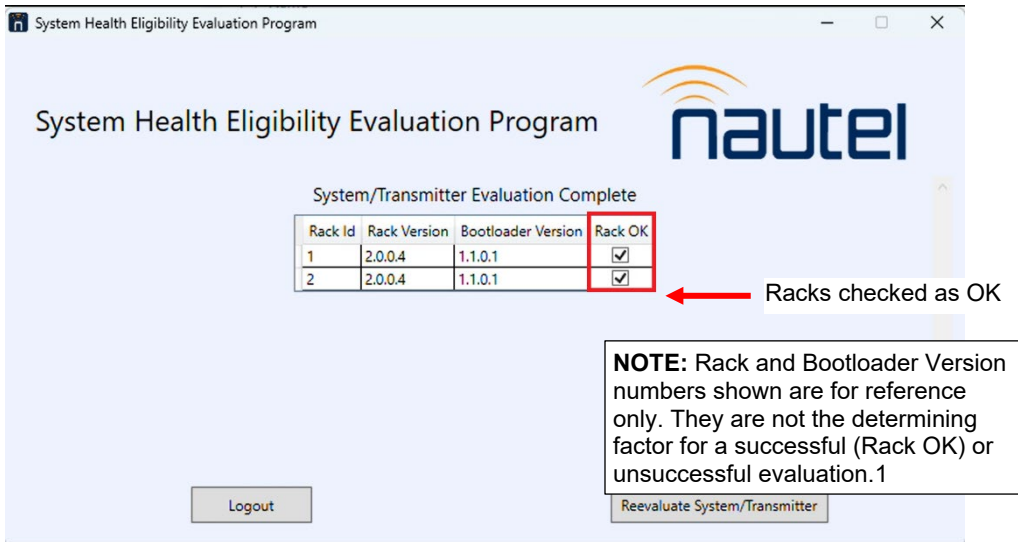
Figure 4: SHEEP successful completion screen

- (h) The program will begin evaluating the 'Rack version' and 'Bootloader version' for each rack in the transmitter. This may take up to two minutes. A progress bar will be displayed throughout the evaluation, along with messages indicating the evaluation details.
- (i) When the evaluation is complete, an information prompt will appear to verify that the AUI is not reporting any alarms before attempting to RF on. If any new alarms are present that were not present in step (d), you will need to cycle (off, then on) the transmitter's ac power. Click **OK** on this prompt to view the evaluation results. Figure 4 shows the completion of a successful evaluation, including the rack and bootloader versions for each rack, plus checkmarks to indicate that the racks (and transmitter) are eligible for software upgrade.

- (k) If the evaluation was successful, your transmitter is eligible for specific software upgrades. Report this to a Nautel Customer Service representative at support@nautel.com to discuss the Field Modification required to proceed.
- (l) If the evaluation was not successful, your transmitter is not yet eligible for specific software upgrades. Click the **Reevaluate System/Transmitter** button to perform the software evaluation again. If still unsuccessful, report this to a Nautel Customer Service representative at support@nautel.com to discuss the Field Modification required to re-program your transmitter's rack firmware.
- (m) Return the transmitter to desired operation.

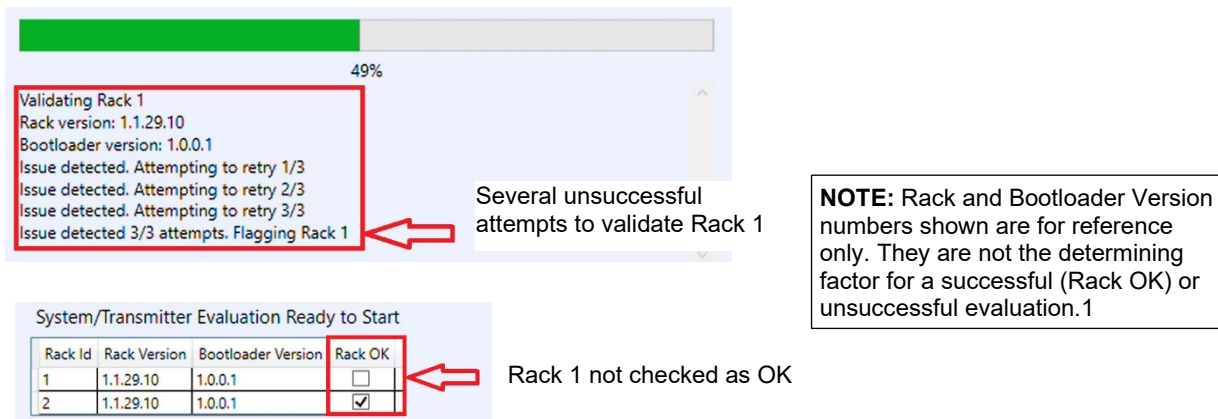
Figure 5: SHEEP unsuccessful progress and completion screen

- (j) If an evaluation discovers an issue with one or more racks, there will be messages like those shown in Figure 5. SHEEP will make several attempts to retry a rack evaluation, before flagging the rack with an issue.
