# Information Sheet IS24005

# GV Series: Using the System Health Eligibility Evaluation Program (SHEEP)

Issue 1.3 .....05 March 2025

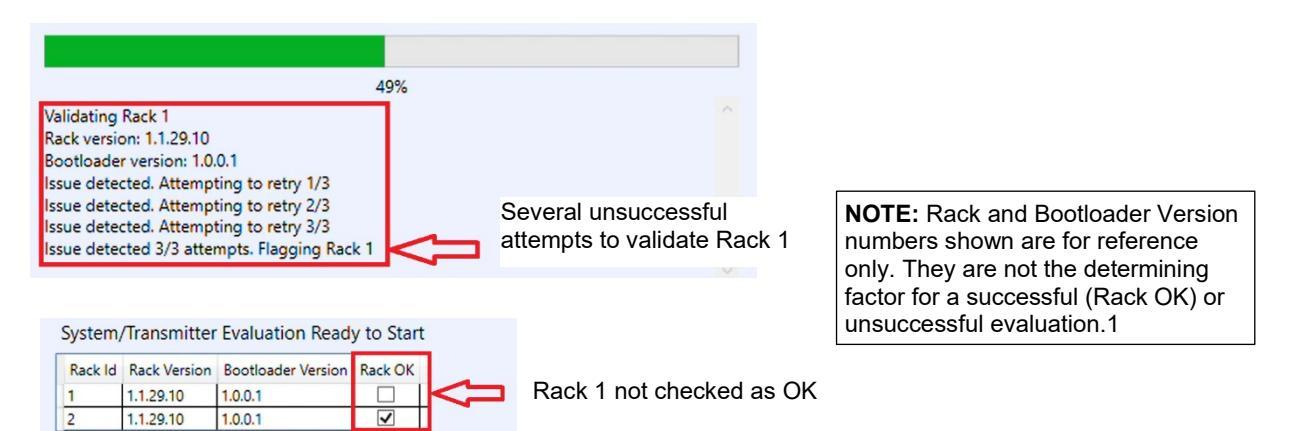
#### Figure 5: SHEEP unsuccessful progress and completion screen

(j) If an evaluation discovers an issue with one or more racks, there will be messages like those shown in Figure 5. SHEEP will make several attempts to retry a rack evaluation, before flagging the rack with an issue.

- (k) If the evaluation was successful, your transmitter is eligible for specific software upgrades. Report this to a Nautel Customer Service representative at <u>support@nautel.com</u> to discuss the Field Modification required to proceed.
- (I) If the evaluation was not successful, your transmitter is not yet eligible for specific software upgrades. Click the **Reevaluate System/Transmitter** button to perform the software evaluation again. If still unsuccessful, report this to a Nautel Customer Service representative at <u>support@nautel.com</u> to discuss the Field Modification required to reprogram your transmitter's rack firmware.
- (m) Return the transmitter to desired operation.
