# **NX15 to NX400 - Software Upgrade to NX SW 5.1.1 or later (CF Card)**

**IS19003A**

# IS19003A - NX15 to NX400 - Software Upgrade to NX SW 5.1.1 or later (CF Card)

## INFORMATION SHEET

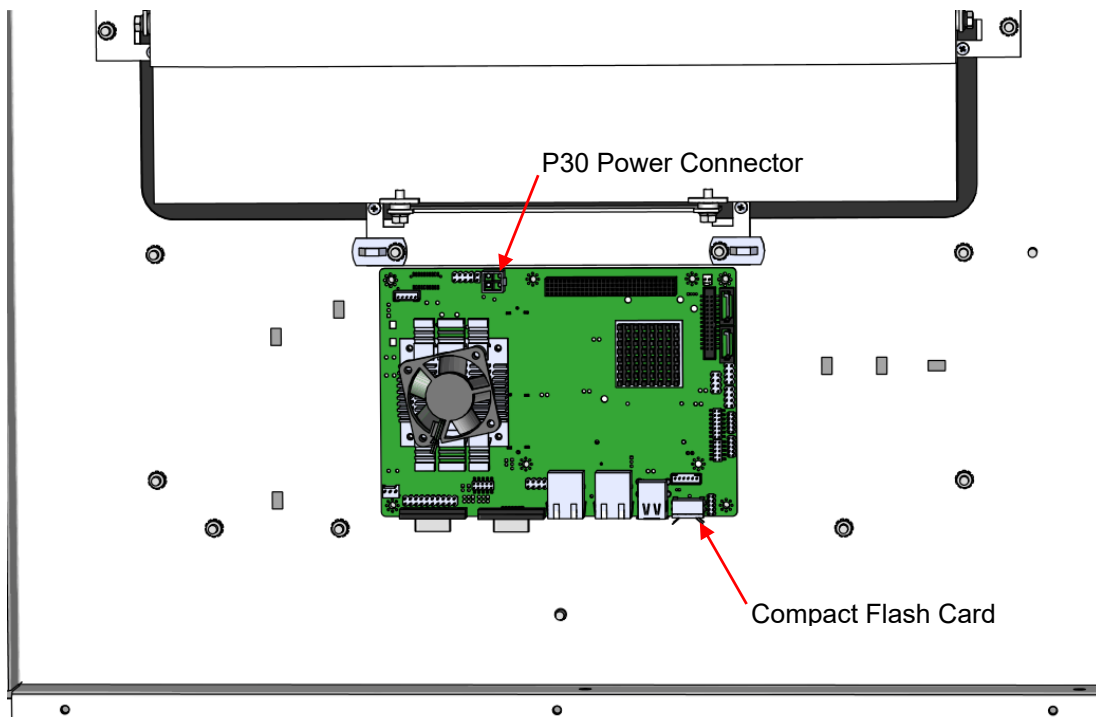
**Figure 1: SBC Power Connector and Compact Flash Card Locations**

- Turn the transmitter to its RF Off state and open the front door to gain access to the SBC.
- Remove the SBC cover located on the back of the transmitter's front door just below the touch screen using a 7-mm nut-driver. Retain the M4 hardware.
- Unplug the single board computer (SBC) 4-pin power connector (P30). See Figure 1.

- Remove the current compact flash card – bottom edge of SBC. Note orientation of card.
