Information Sheet IS24005

GV Series: Using the System Health Eligibility Evaluation Program (SHEEP)

Issue 1.1 24 January 2025

Nautel Limited

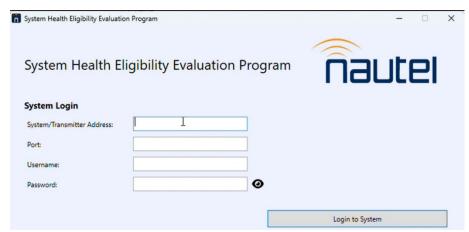
Figure 1: SHEEP login screen

- (a) Set the transmitter to remote-enabled mode via the local AUI touch screen, controller UI, or remote interface PWB. Refer to the *Operation & Maintenance Manual* for instructions.
- (b) Download the SHEEP executable file (see link below) to a laptop that will have access to the same network used by the GV transmitter.
 - http://www3.nautel.com/pub/Utilities/SystemHealthEligibilityEvaluationProgram.exe
- (c) Run the SHEEP executable file by double-clicking the downloaded file. The screen shown in Figure 1 will display.

(d) Enter the **System Login** parameters for the transmitter's remote AUI, including System/Transmitter (IP) Address, Port (default is 3501), Username (default is Nautel) and Password (default is no password). Click **Login to System**. If the connection is successful, the screen in Figure 2 will display. If the connection is unsuccessful, a connection error message will appear. In this case, verify the system/transmitter IP address and port number in the AUI's **Menu -> User Settings -> Network Setup** screen, re-enter the **System Login** parameters, and try again.
