Information Sheet IS23006

VX Series – Software Upgrade Procedure

IS23006: VX Series – Software Upgrade Procedure

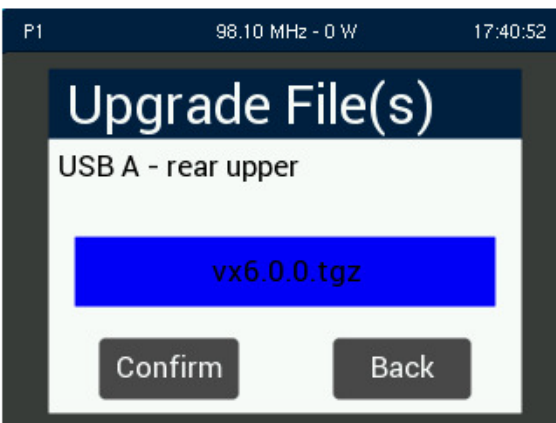
Figure 2: Upgrade File(s) screen - FPUI

- (a) Using the transmitter's FPUI, navigate to the **Main Menu ▶ Software ▶ Upgrade File(s)** screen (see Figure 2).
- (b) Select the desired .tgz file from the list and select **Confirm** to initiate the upgrade process.

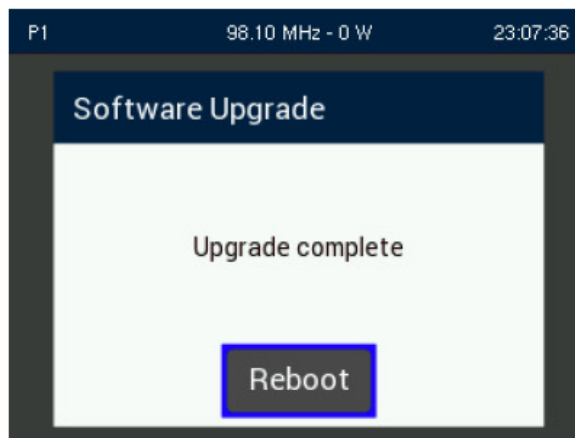
Figure 4: Software Upgrade complete - FPUI

(d) If the software upgrade is successful, a pop-up screen will be displayed, indicating that a system reboot is required for the new software installation to be completed (see Figure 4). Select **Reboot**.

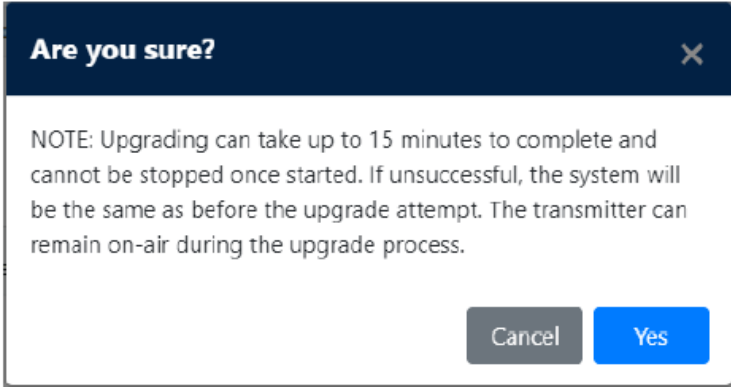
Figure 9: Upgrade Warning – Remote AUI

- (e) Select the upgrade file from the list and click the green **Start Upgrade** button to initiate the software upgrade process. A warning will be displayed (see Figure 9), indicating that the upgrade can take up to fifteen (15) minutes to complete and cannot be stopped once started. Also, the transmitter can remain in an on-air state during the upgrade. Select **Yes** to start the upgrade process or **Cancel** to not proceed with an upgrade.

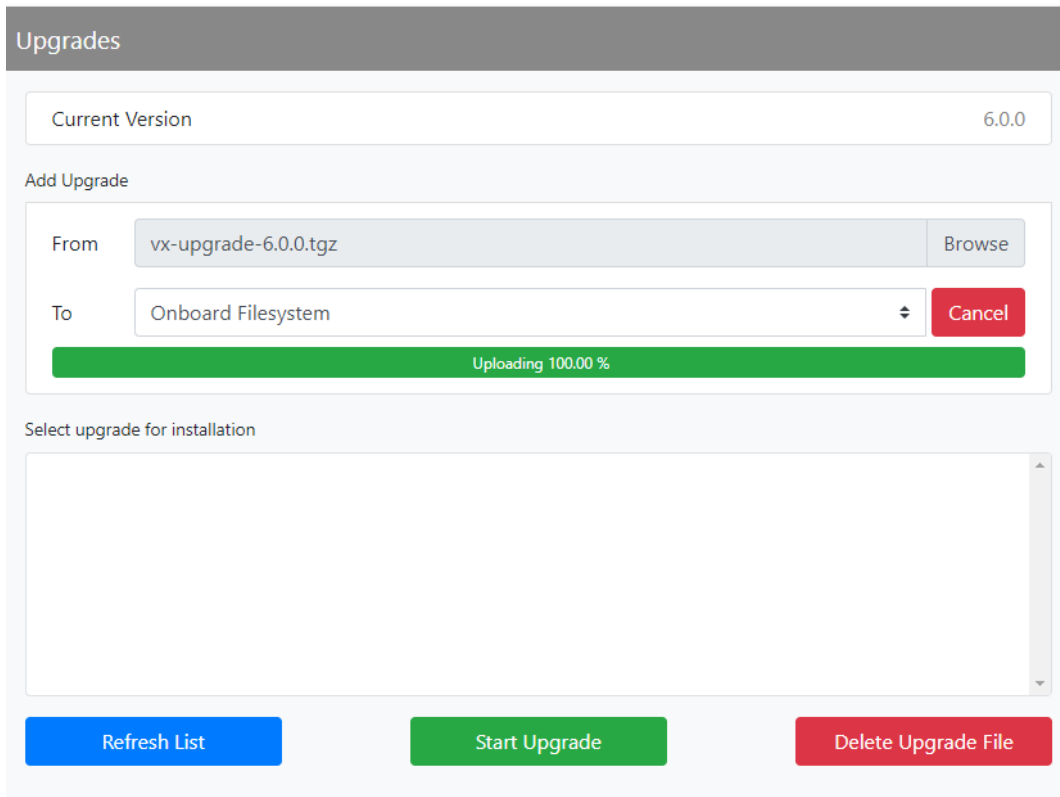
Figure 10: File upgrade in process – Remote AUI

- (f) A status bar will be displayed showing the percentage completed (see Figure 10).

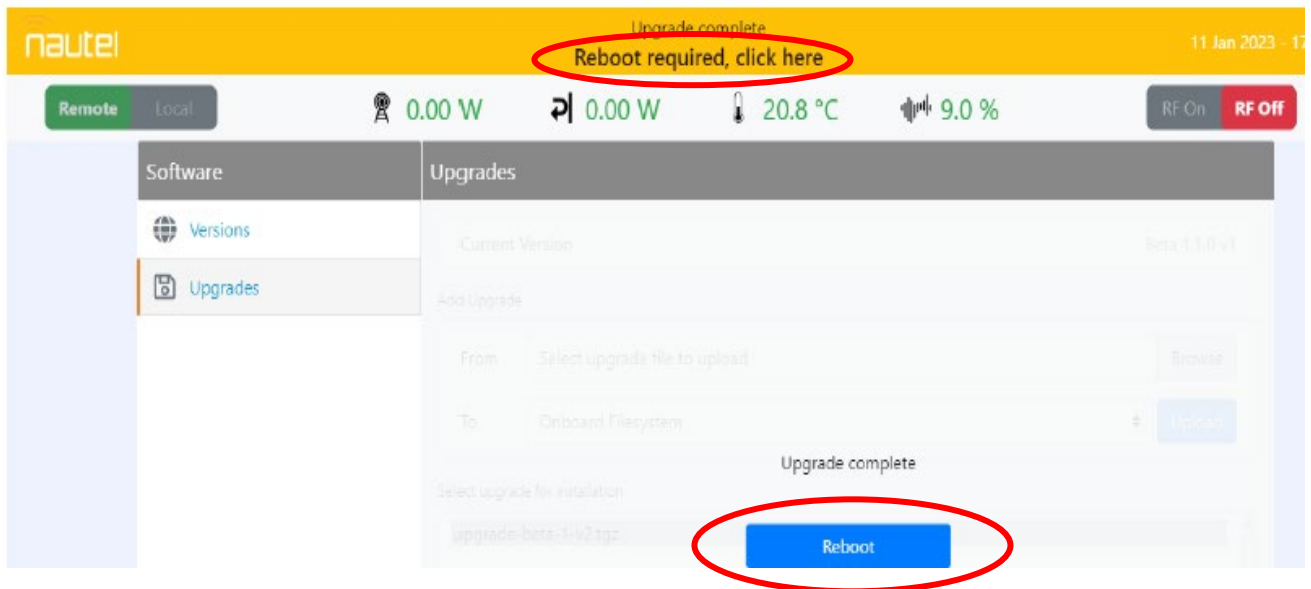
Figure 11: File upgrade complete/reboot – Remote AUI

- If the upgrade was successfully completed, the transmitter will require a reboot. Select the Reboot button or the link in the top banner to start the reboot process (see Figure 11).
- If the upgrade failed, the Operating System will remain unchanged and a pop-up screen will be displayed for the user to acknowledge the failed attempt.

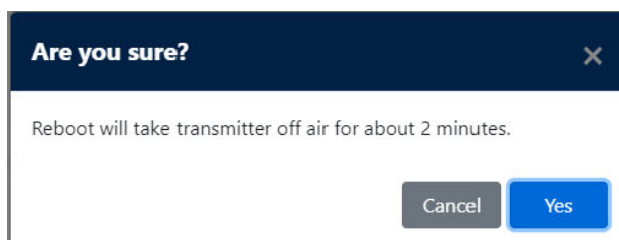
Figure 12: Reboot Warning – Remote AUI

(h) Upon selecting **Reboot**, a warning will be displayed (see Figure 12), indicating that the transmitter will be off-air for between two and five minutes during a reboot. Select **Yes** to reboot that transmitter or **Cancel** to revert to the previous software.
